FHWA/CA/TL-88/05

June 1988

Office of Transportation Laboratory
California Department of Transportation
Sacramento, California 95819

TENSAR REINFORCED SOIL

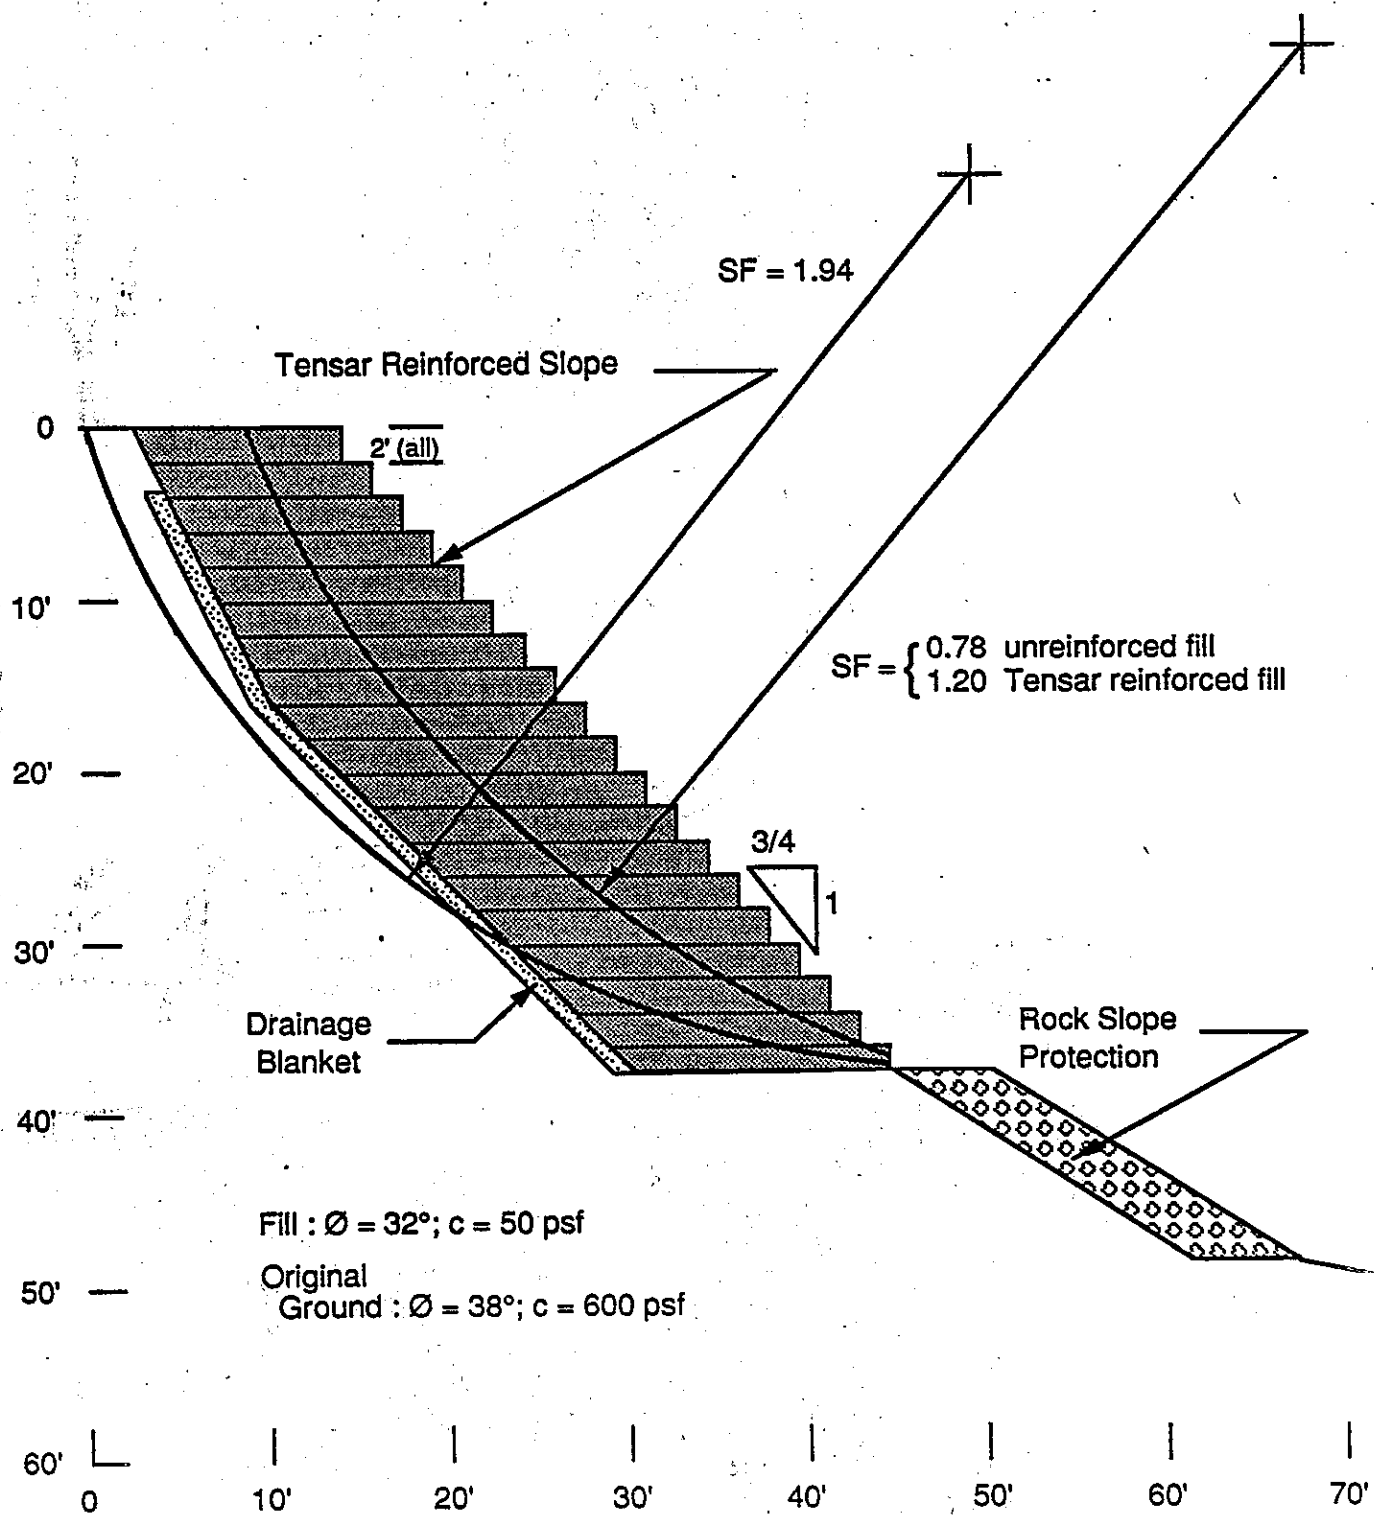
resulted in a global safety factor of 1.96. The compacted embankment had assumed (minimum) strength values of $\phi = 32$ degrees and cohesion equal to 50 psf resulting in minimum safety factors of 0.78 (unreinforced fill) and 1.20 (Tensar reinforced fill). Fill cross section and failure arcs are illustrated in Figure 2.

Figure 2 - Cross Section of Tensar Reinforced Slope illustrating critical failure arcs and components of slope design.

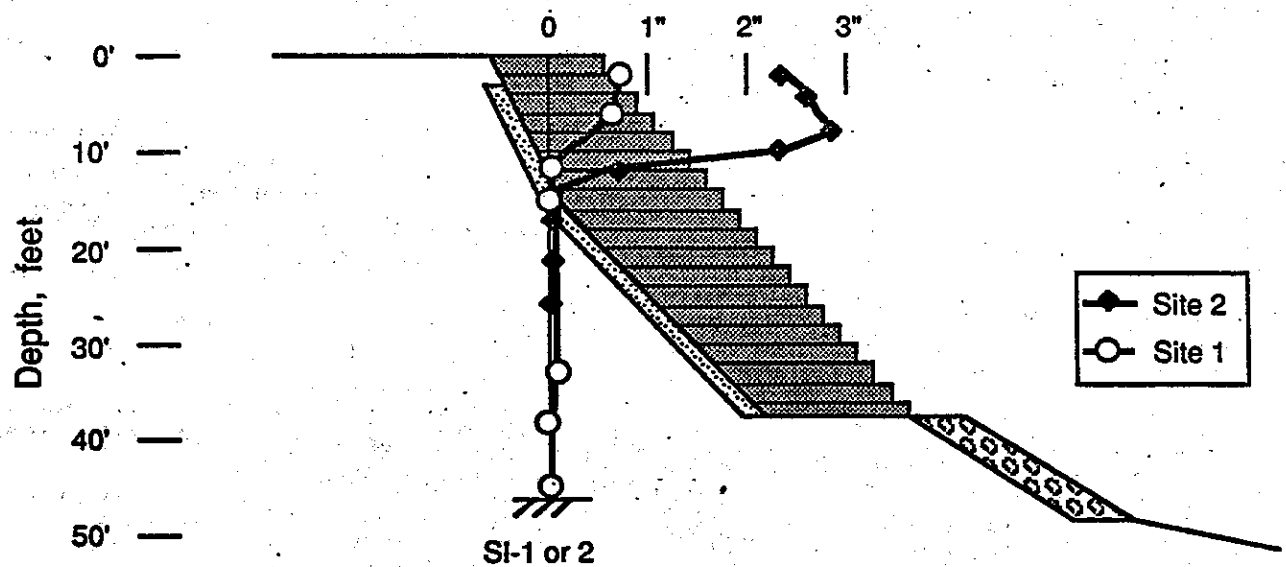
These data are best presented as movement versus depth and movement versus time as shown in Figures 3a and 3b.

Figure 3a - Cross Section of Tensar Reinforced Slope Showing Final Slope Indicator (SI) Deflection at Site 1 and Site 2.

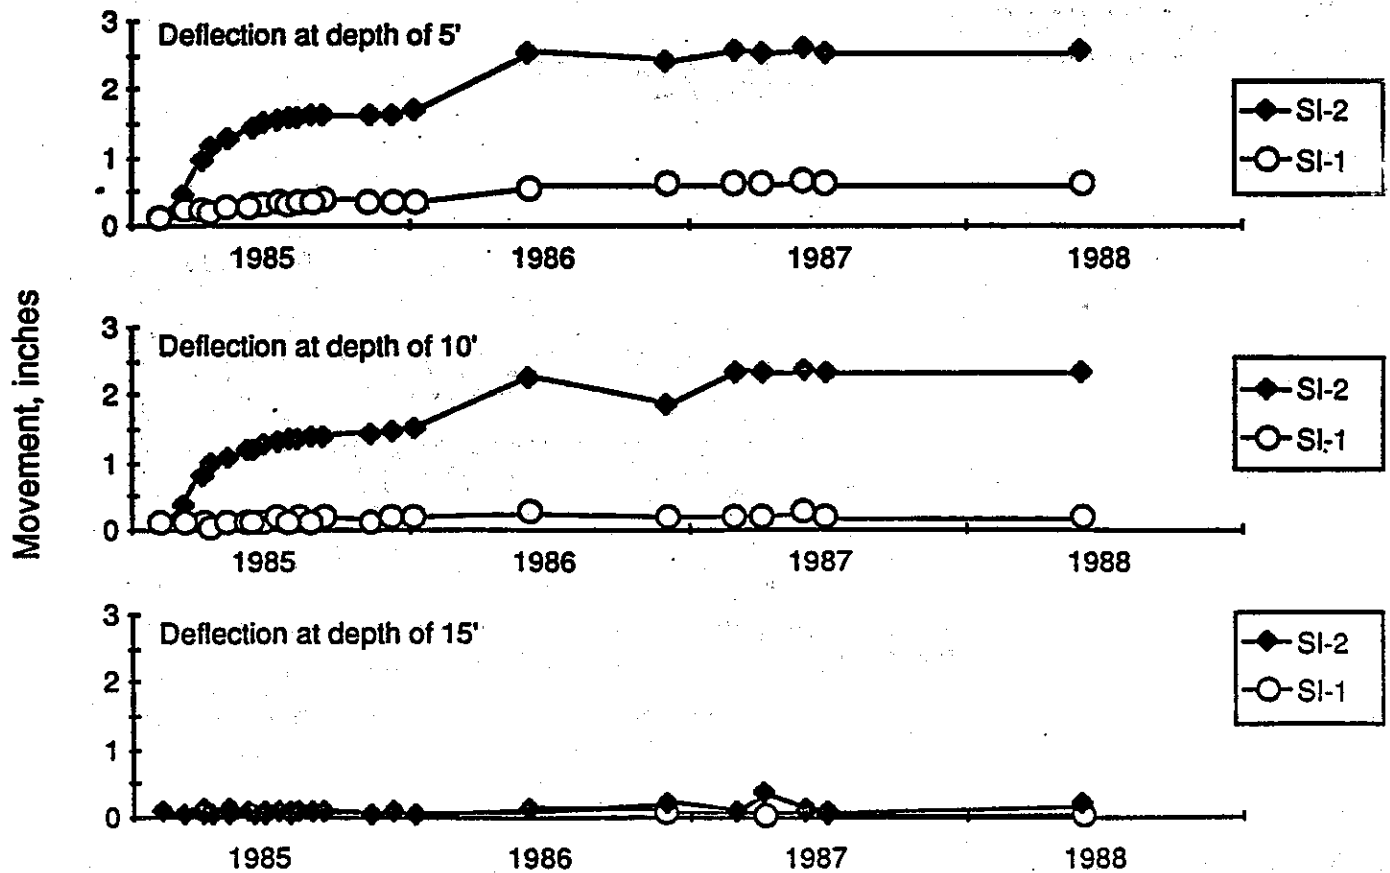
Figure 3b - Time - History of Deflection at Indicated Depths for SI-1 and SI-2.

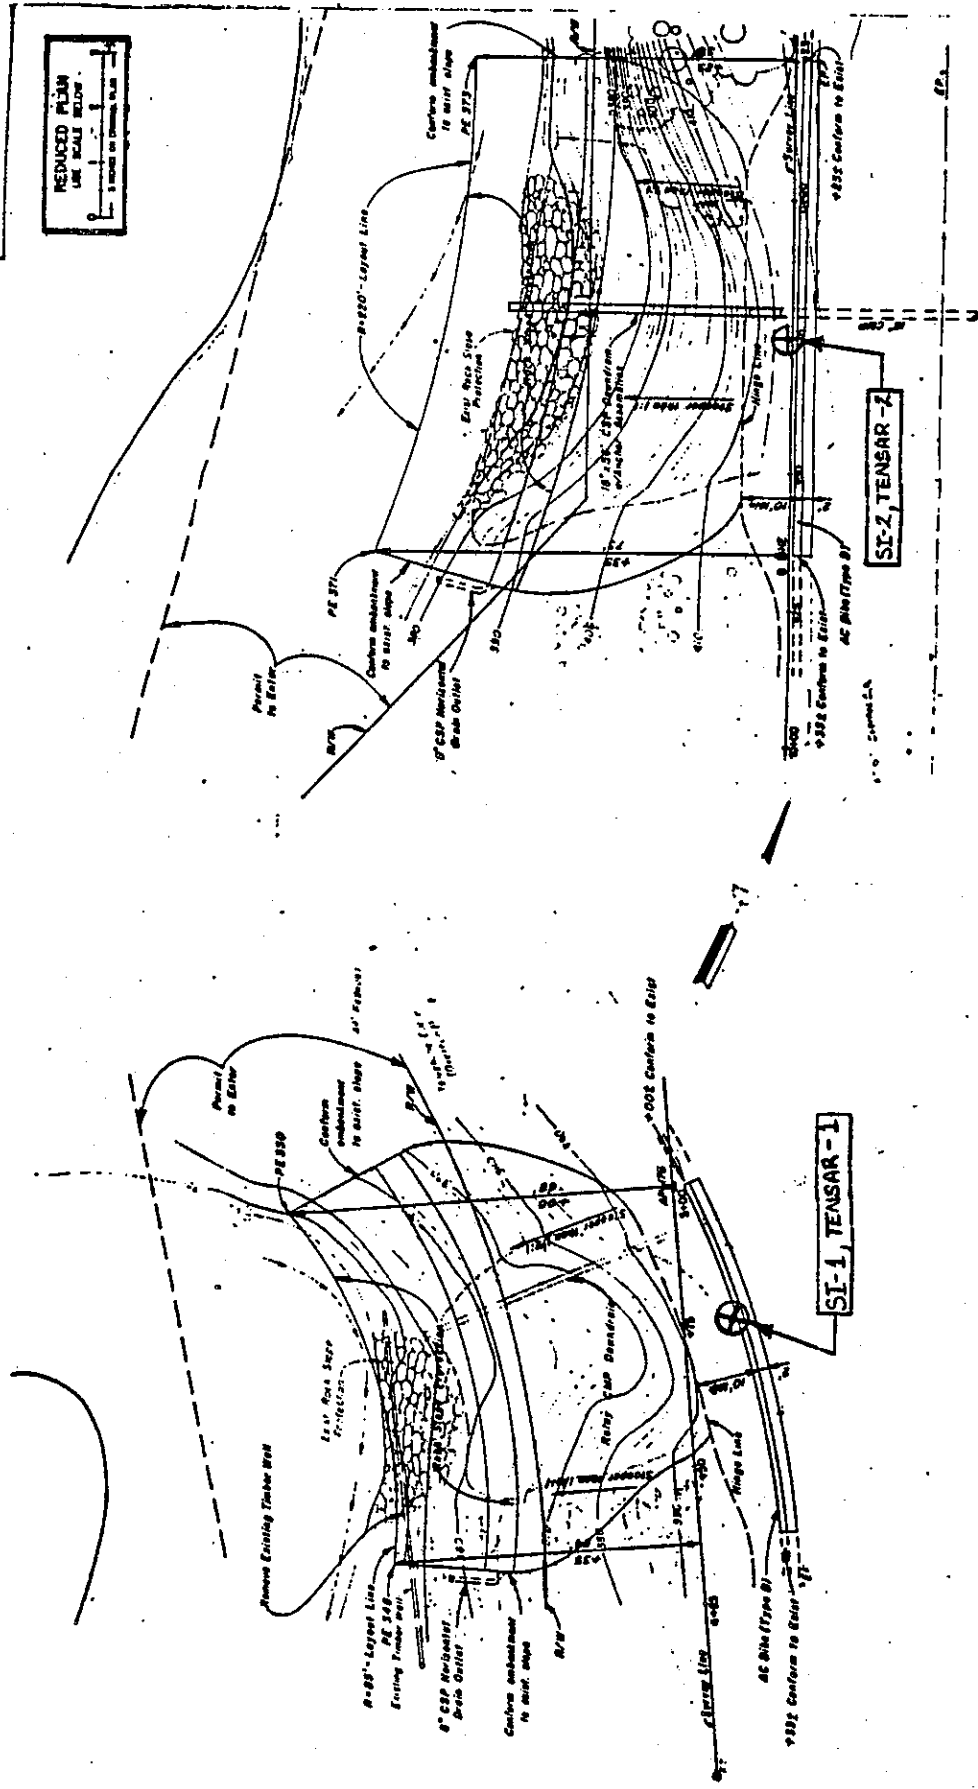
Figure #5. Location of Slope Indicator Sites.

Slope indicators were installed at the approximate centerline of each embankment just outside of the asphalt drain on the shoulder, see Figure #5. Indicator #SR1 was installed in the embankment at PM 9.85 to a depth of 46 feet. Indicator #SR2 was installed in the embankment at PM 10.05 to a depth of 28 feet. The casing heads rise 3 to 8 inches above the ground and have a locking cap to protect the casing from vandalism, Photograph #18 (arrow). Logs of the borings are shown in Appendix C. Both logs show that the embankment is about 13 feet thick at the slope indicators.

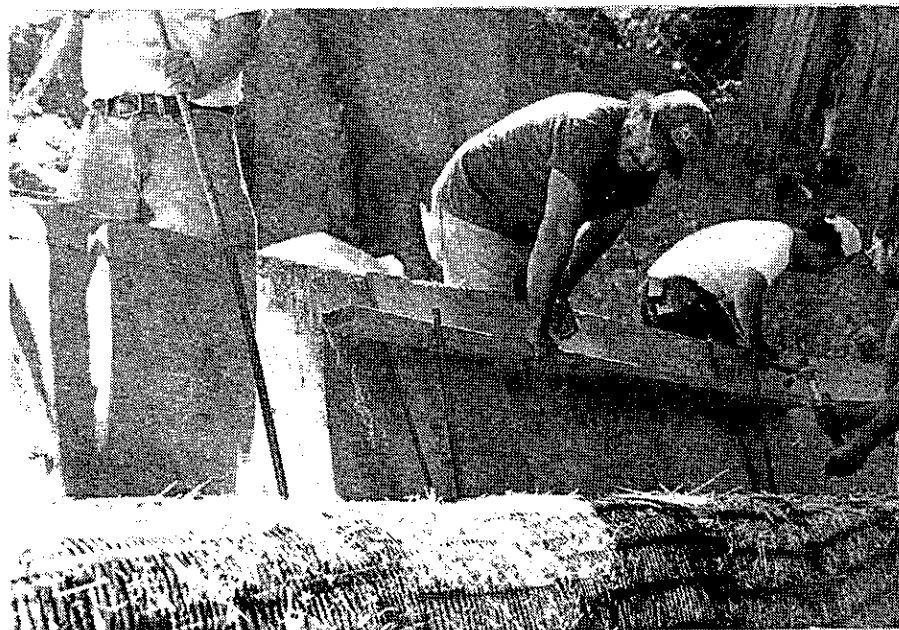
The reinforced section was placed in two foot-lifts from the top of the unreinforced section to within three feet of the top of the embankment, Figure #4b. Each lift was formed as a step by first placing temporary plywood batter forms as shown in Photograph #05.

Plywood batter.

Restrains compacted
backfill until the
geogrid is lapped
and fastened.

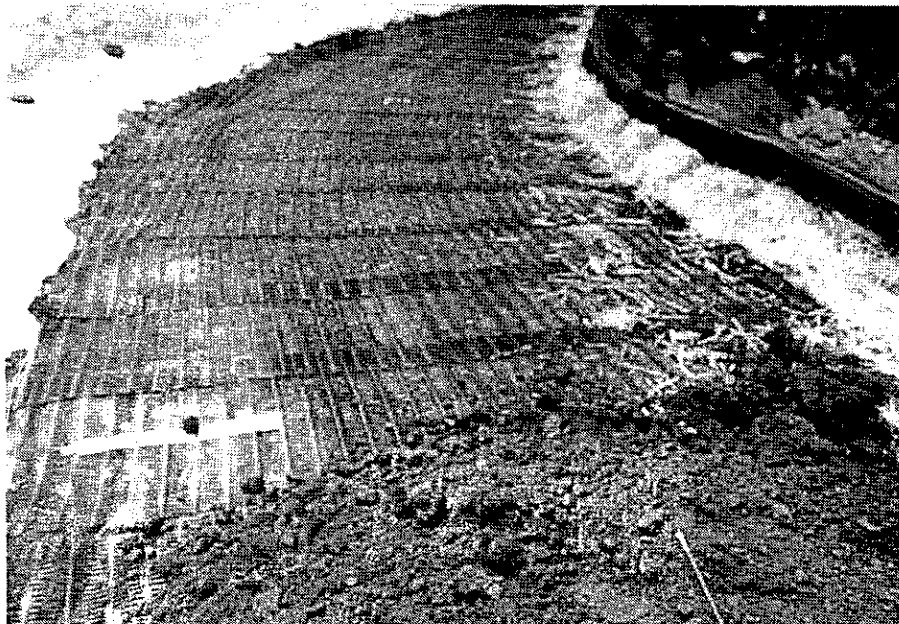
Photograph #06.

Backfilling.

Soil is placed over
geogrid and against
straw at the batter.

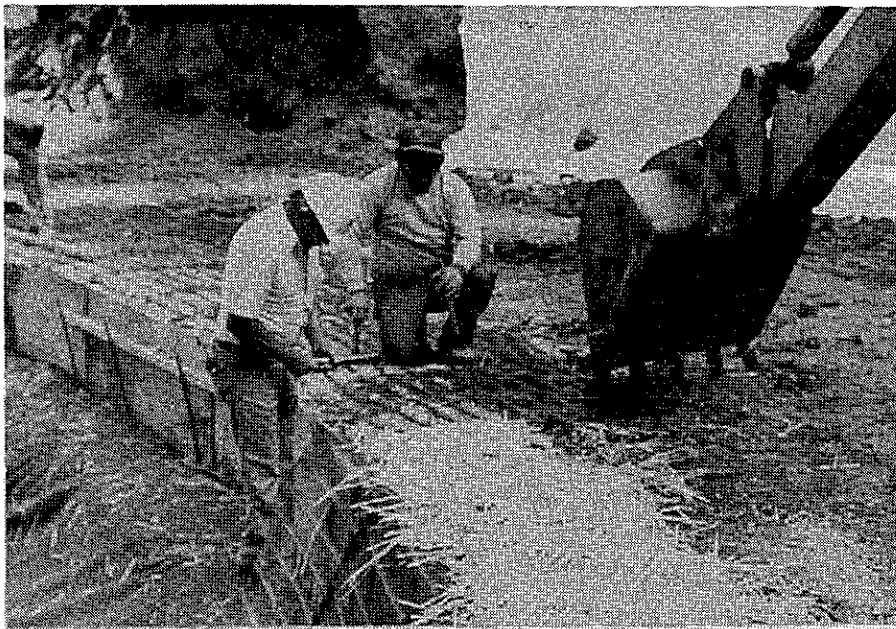
Photograph #07.

Lift completion.

Geogrid is lapped over the top of the step and held by backhoe until secured by hand.

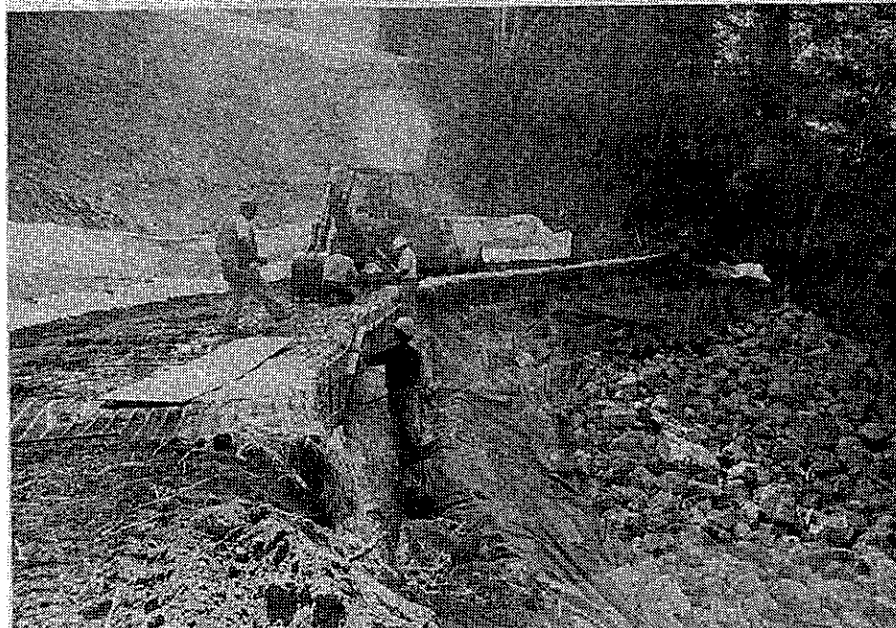
Photograph #08.

The unreinforced section was placed from the foundation to a height of fifteen feet, Photograph #04, and protected from stream erosion by a rock slope. The rock slope, which can be seen in Photographs #08 and #09, was keyed into the original ground to a minimum depth of five feet adjacent to the creek. The Resident Engineer extended the limits of the rock slope protection at both embankments to increase rigidity and stability.

Lift completion.

Same as in previous photograph.

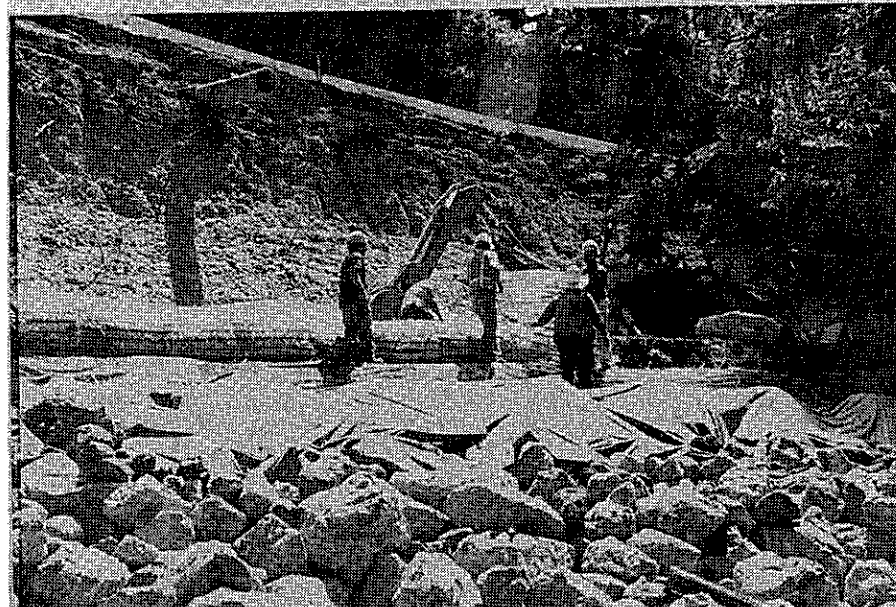
Photograph #09.

Same as in previous photograph.

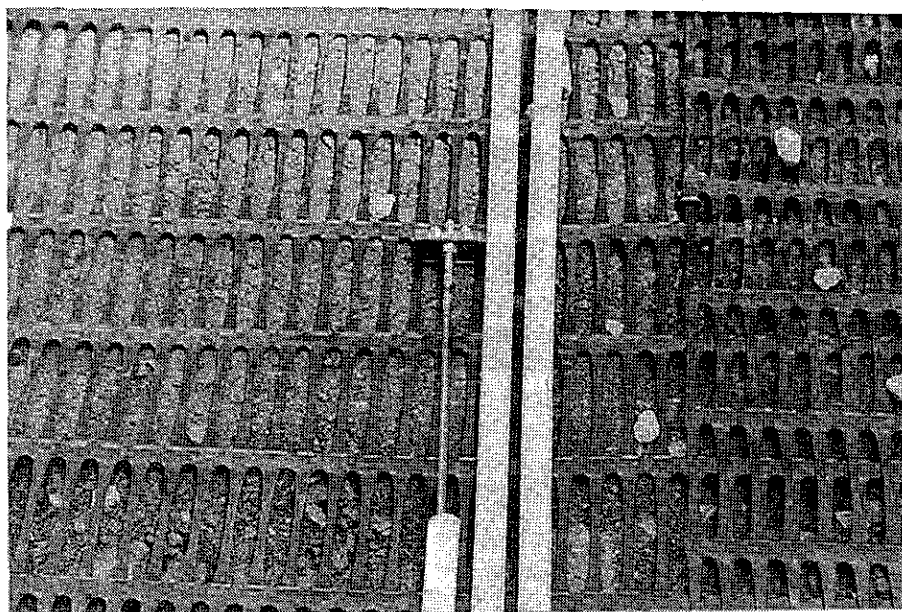
Photograph #12.

Extensometer
installation.

End of extensometer
rod secured to
geogrid.

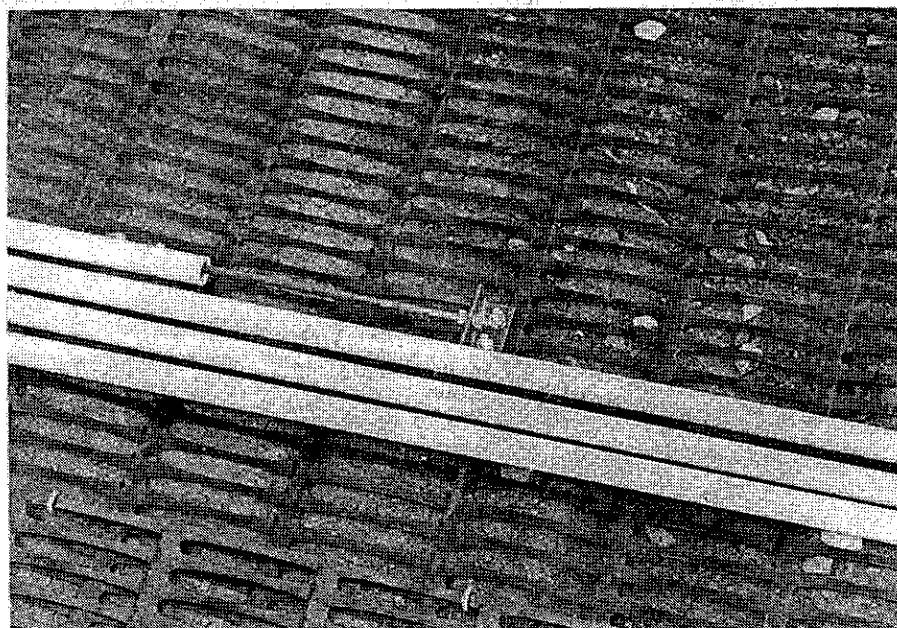
Photograph #13.

Extensometer
installation.

Same as previous
photo.

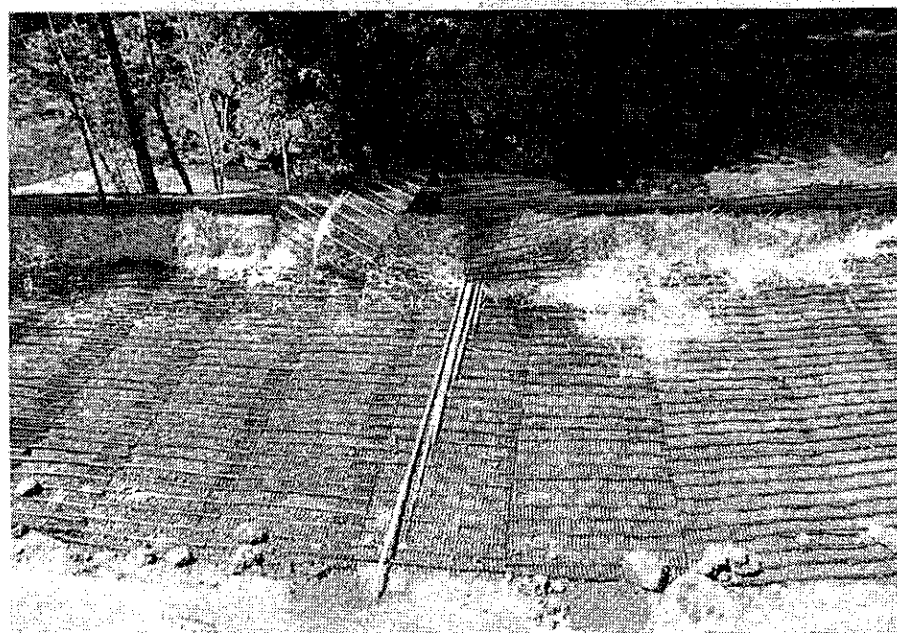
Photograph #14.

Extensometer
installation.

Rods in PVC pass
through face of
step.

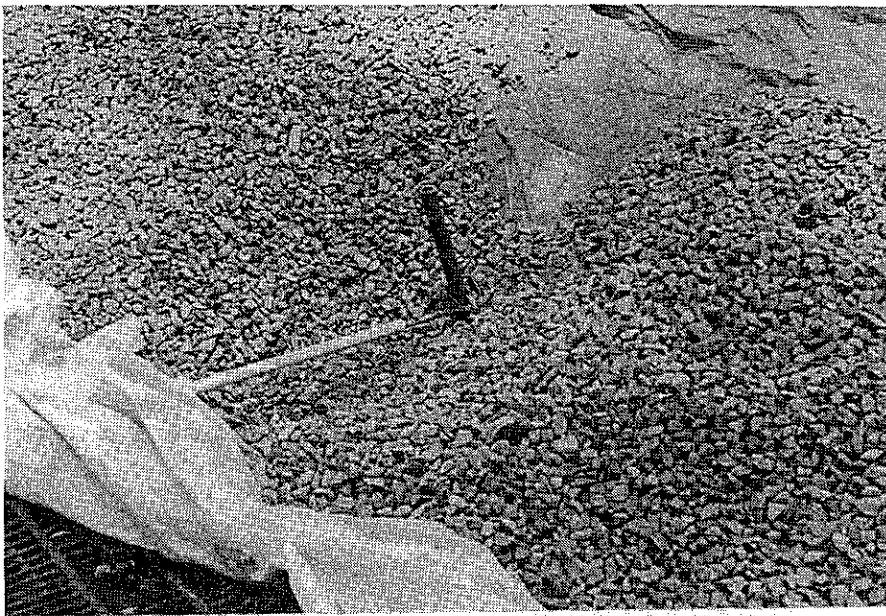
Photograph #15.

Extensometer
installation.

Anchor rod fastened
in original ground.

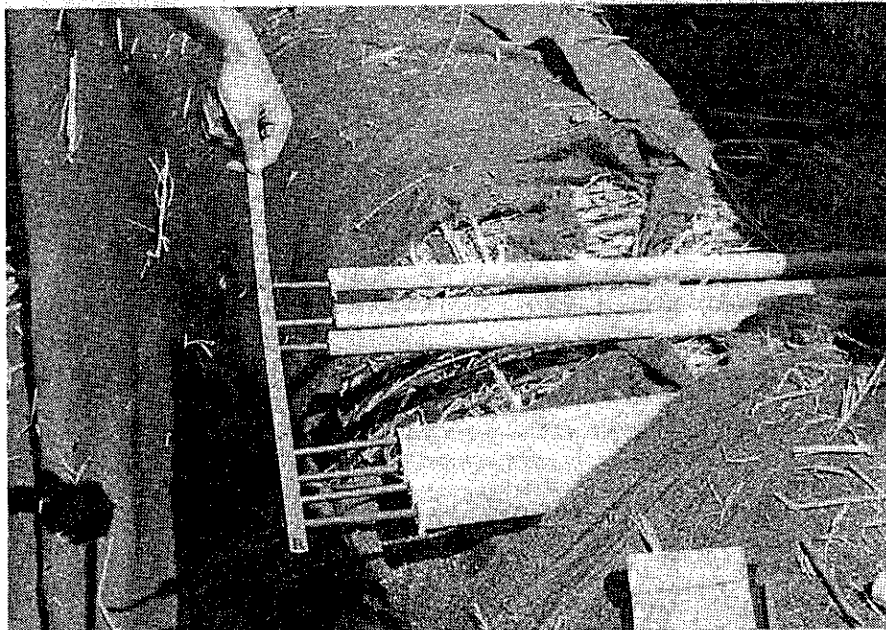
Photograph #16.

Extensometer
installation.

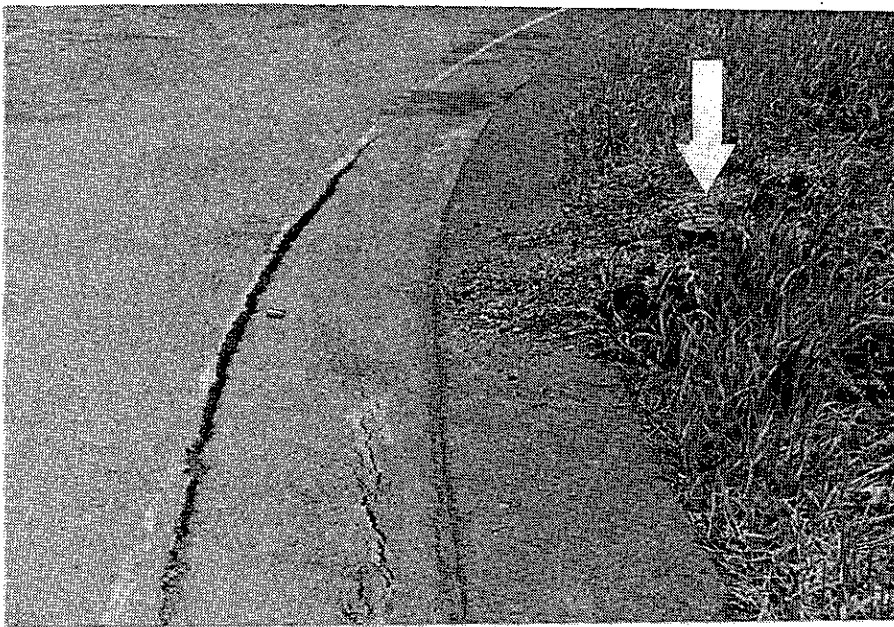
Photograph #18.

Slope indicator.

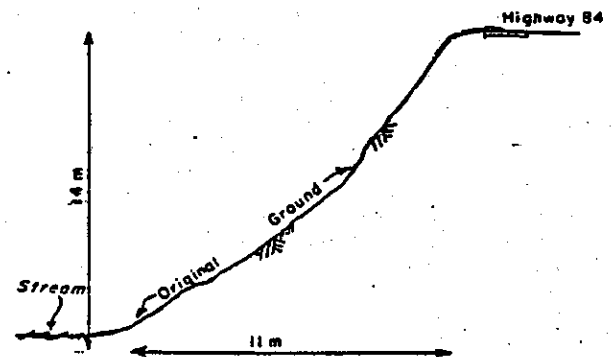
Fig. 1 Cross-section Diagram

The slipout site is 70 m in length requiring slopes varying from 1.5:1 to approximately 1:1. The streambed is 14 m below the freeway grade and 11 m laterally from the hinge point on freeway grade at the critical cross-section. Access to the area is limited. The water table fluctuates up to 3 m and corresponds with changes in the stream elevation. Acquisition of additional right-of-way was not possible.

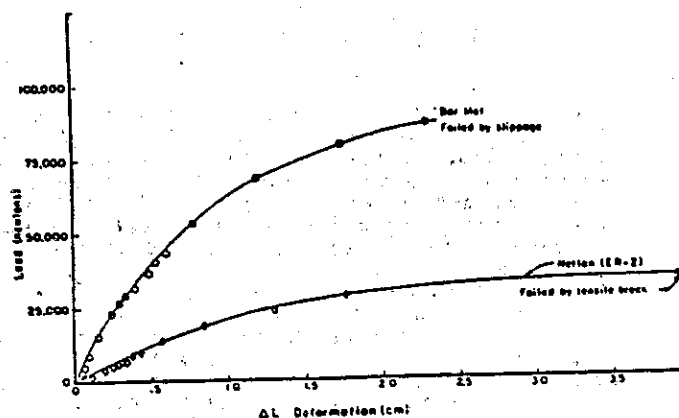
Graph 1: Load Versus Deformation Characteristics of Bar Mesh & Tensar ER-2

Utilizing decomposed granite from an unspecified site as fill (ϕ equal to 35°) and imposing an overburden load equal to 34.5 kPa, the geogrid was pulled to failure. The Tensar ER-2 failed in tension outside the soil block (Plates 1 and 2) at a load of 44,000 newtons/meter indicating design would be limited by the geogrid material's maximum tensile strength. Load versus deformation curves were developed from the pullout tests including a comparison between Tensar ER-2 and bar mesh reinforcement (Graph 1). Bar mesh reinforcement of soil has been used by Caltrans to strengthen wall supported embankments(2). The bar mesh (constructed from 0.95 cm diameter reinforcing bar welded to form 10 cm by 20 cm spacings) has sufficient steel to preclude tensile rupture and force a slippage failure within the soil block. Thus, the bar mat fails in pullout producing a cone shape failure near the soil face. From the graph, the ultimate strength of the Tensar can be obtained and used in design calculations.

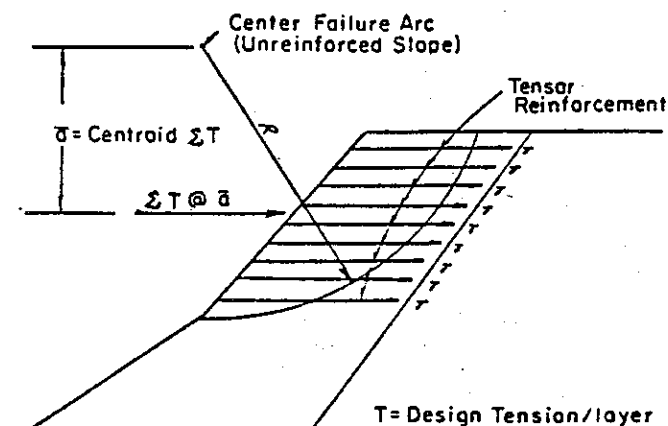
Fig. 2 Determining the centroid of Tensar Moment

The coordinates of the failure arc and the location of the centroid of the reinforcement are used to determine the distance (\bar{a}) to the centroid of reinforcement. In this case, $\bar{a} = 14.3$ meters (Figure 2).

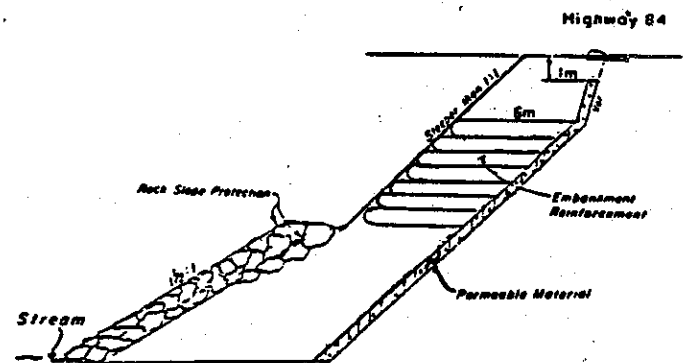
Fig. 3 Final Design Geometrics

Based on these calculations, vertical spacing of the Tensar was standardized at 0.6 meter. Circular failure arcs were plotted to assure that the embedment depth of the reinforcement was sufficient to preclude pullout of the Tensar. Figure 3 illustrates the geometrics of the critical cross-section. The embankment is approximately 14 m high. The lower 4.5 m has a slope ratio of 1.5:1 and is covered with 1 meter of rock slope protection to prevent water scour. The slope ratio in the upper reinforced portion of the embankment is steeper than 1:1. Permeable material lined with filter fabric is placed at the interface of the original ground and the reconstructed embankment. The permeable blanket drains into a horizontal outlet pipe located at the embankment base. The Tensar geogrid extends from the permeable material to the slope face.

Each layer of reinforcement will be folded back a minimum of 1.3 m and anchored in place. The face of the embankment is lined with compacted straw. The total amount of Tensar SR-2 required to complete the slope is 6000 square meters.
